News Post: 3/7/19

Wet Well Inspection at Rio Water Reclamation Plant

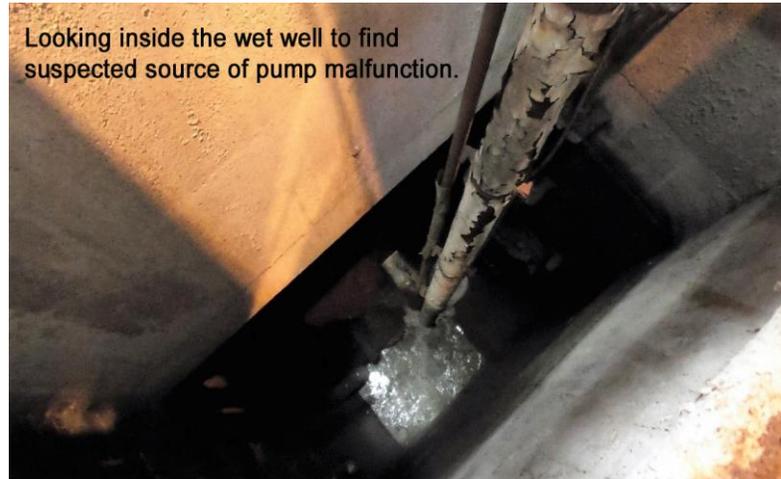
Looking inside the wet well to find suspected source of pump malfunction.

It turned out, the needed repairs were able to be performed outside the wet well. While the conditional inspection was helpful, it serves as a reminder to incorporate safe access in all of our wet wells and vault designs for the future.
