# Museum Fire Response and Risk Assessment

November 7, 2019

MUSEUM FIRE RESPONSE AND RISK ASSESSMENT

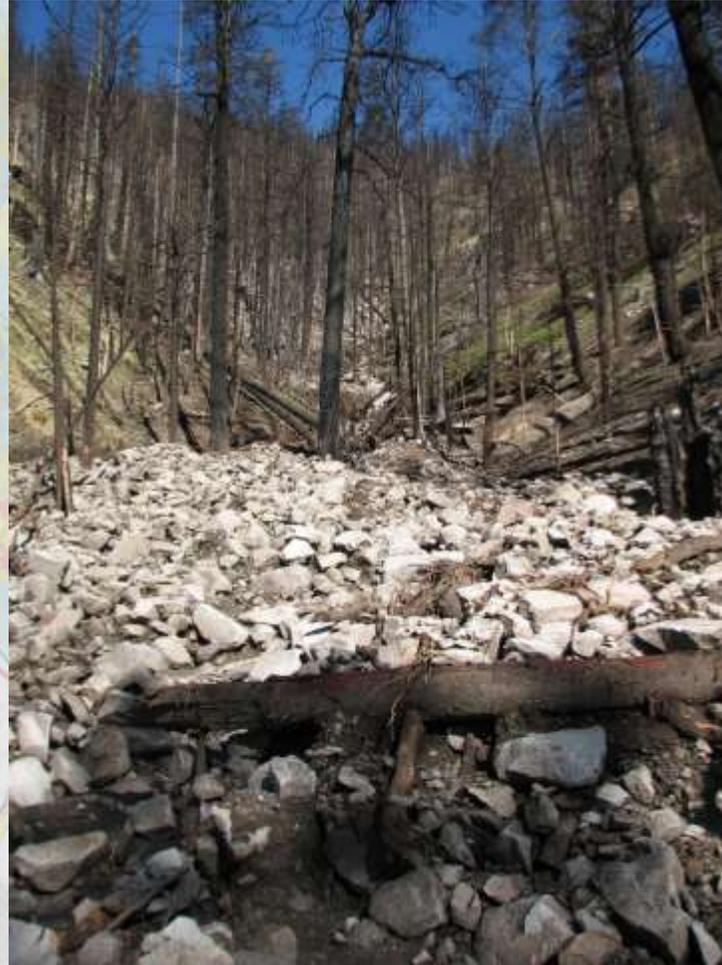
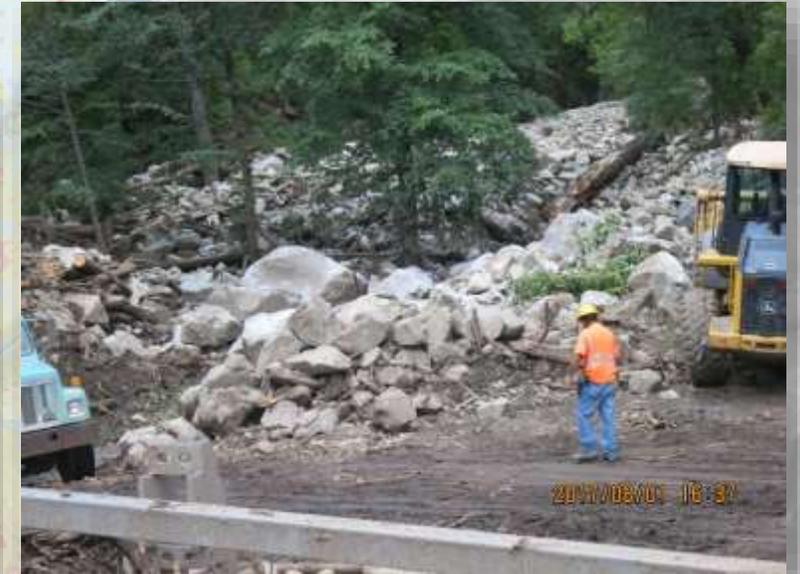
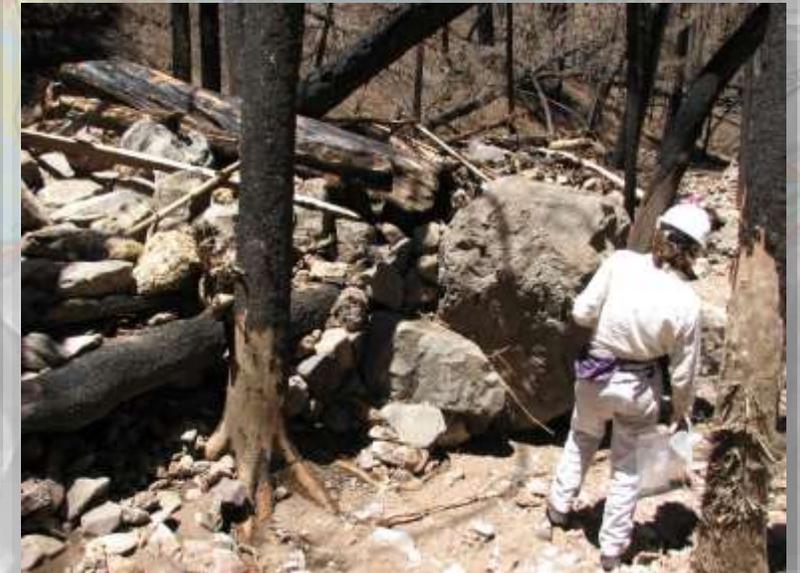
## USGS Debris-Flow Volume Model

Debris-flow volume determined by:

- Elevation range within the watershed (m)
- %upslope area burned at mod/high SBS (km<sup>2</sup>)
- $I_{15}$  rainfall intensity (mm/h) of the design storm

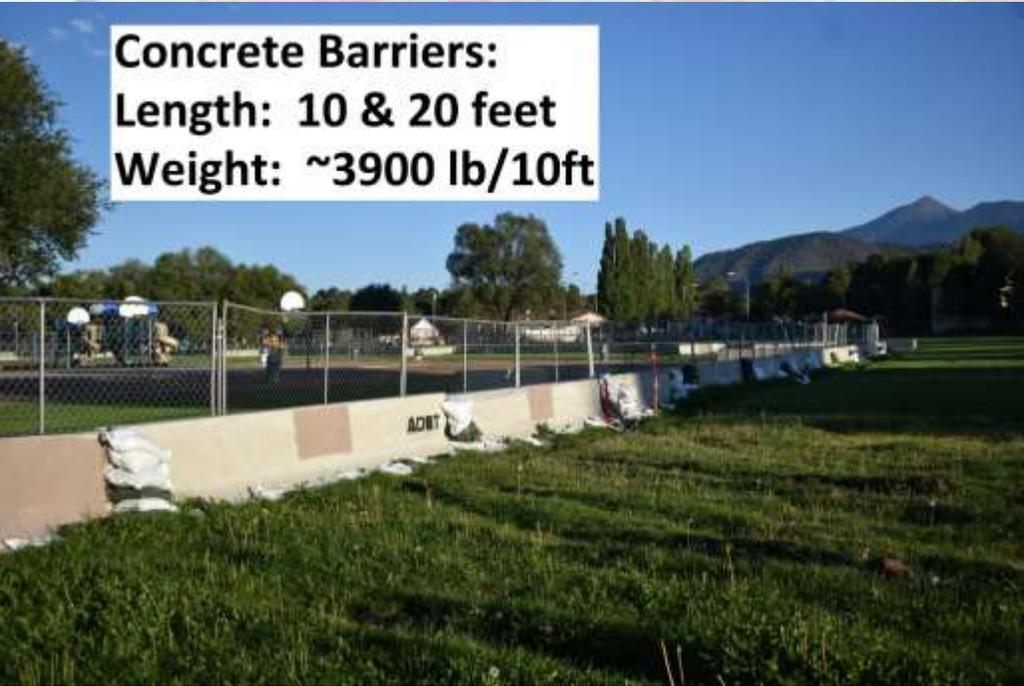
- Mitigated ~400 homes & ~35 businesses in ~2 weeks
  - Concrete barrier placement
  - Water barrier placement
    - For high-hazard area
    - Water barriers are used in lieu of concrete barriers where accessibility is an issue

**Concrete Barriers:**  
Length: 10 & 20 feet  
Weight: ~3900 lb/10ft

A photograph showing a long concrete barrier placed in a grassy area next to a chain-link fence. The barrier is light-colored with some darker sections. In the background, there are trees and mountains under a clear blue sky.

**Water Barriers:**  
72 x 24 x 42 in  
Weight: 12.5 lb

A photograph showing a line of water barriers (orange and white plastic barrels) placed in a wooded area. A metal post is visible in the foreground. The date stamp '07/27/2019' is visible in the bottom right corner.

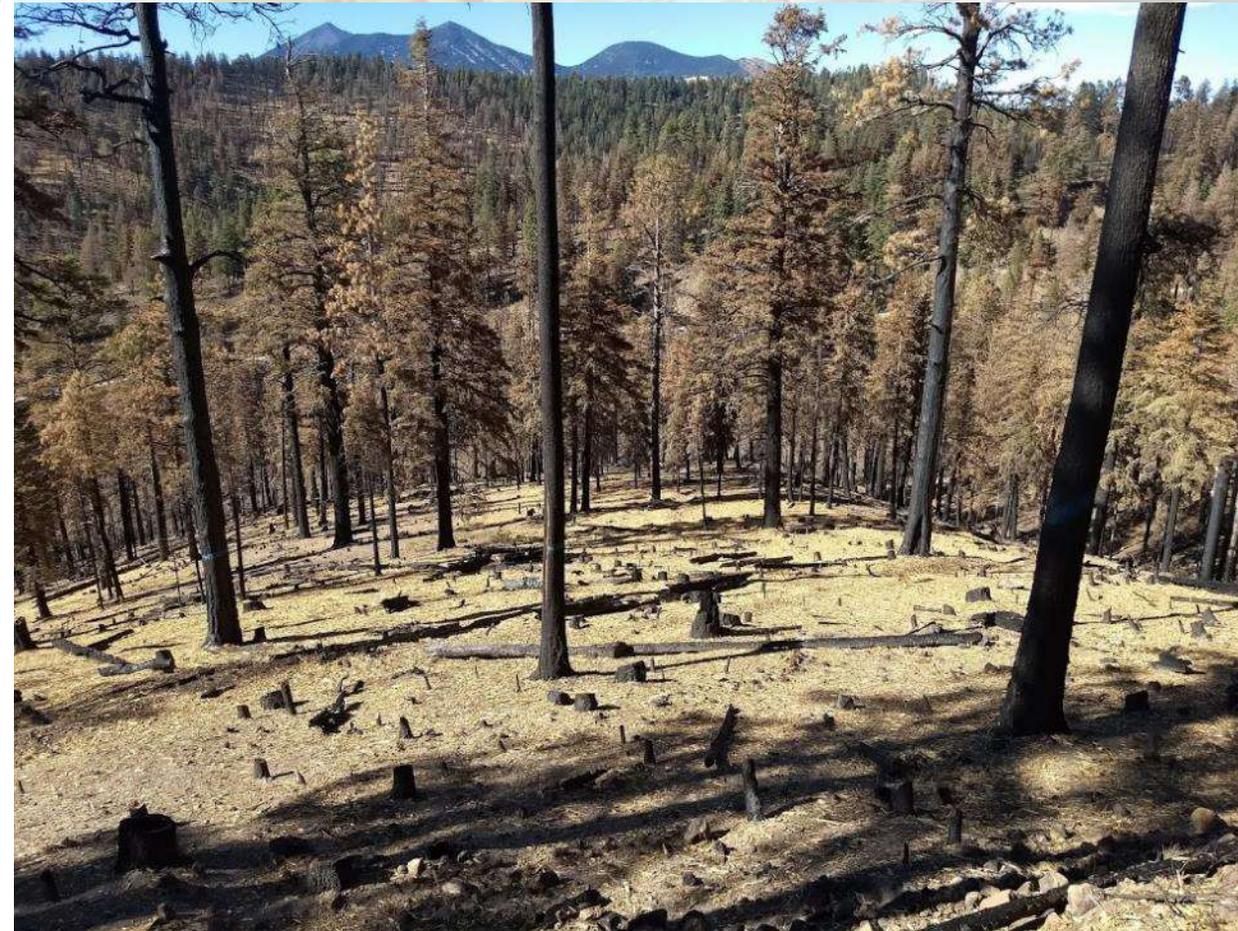
160 acres of mulch spread on severe burn steep slopes (September 2019)

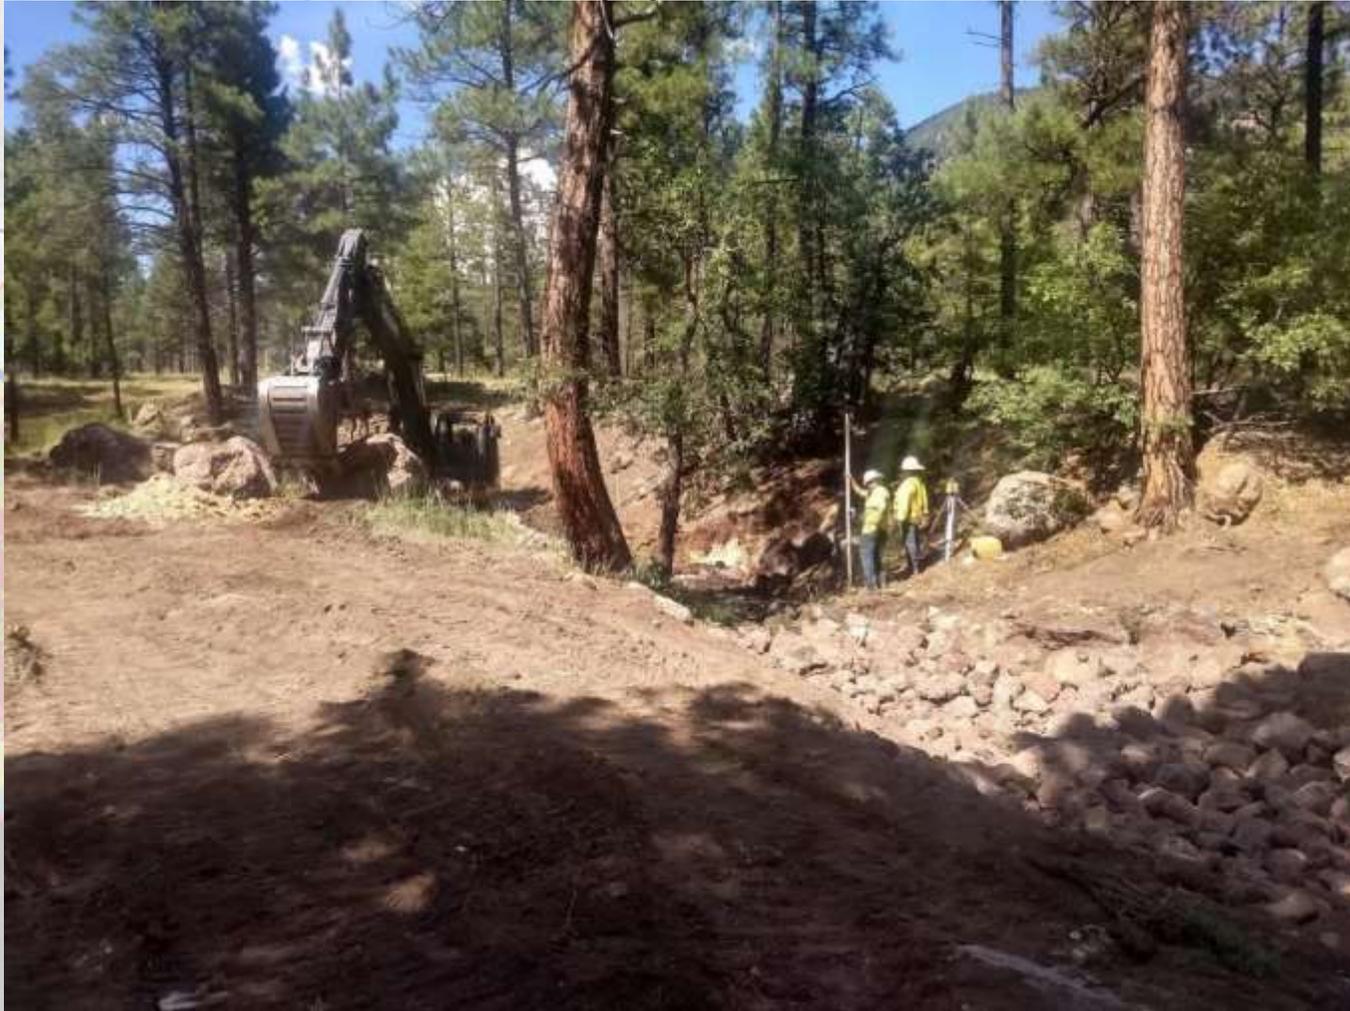
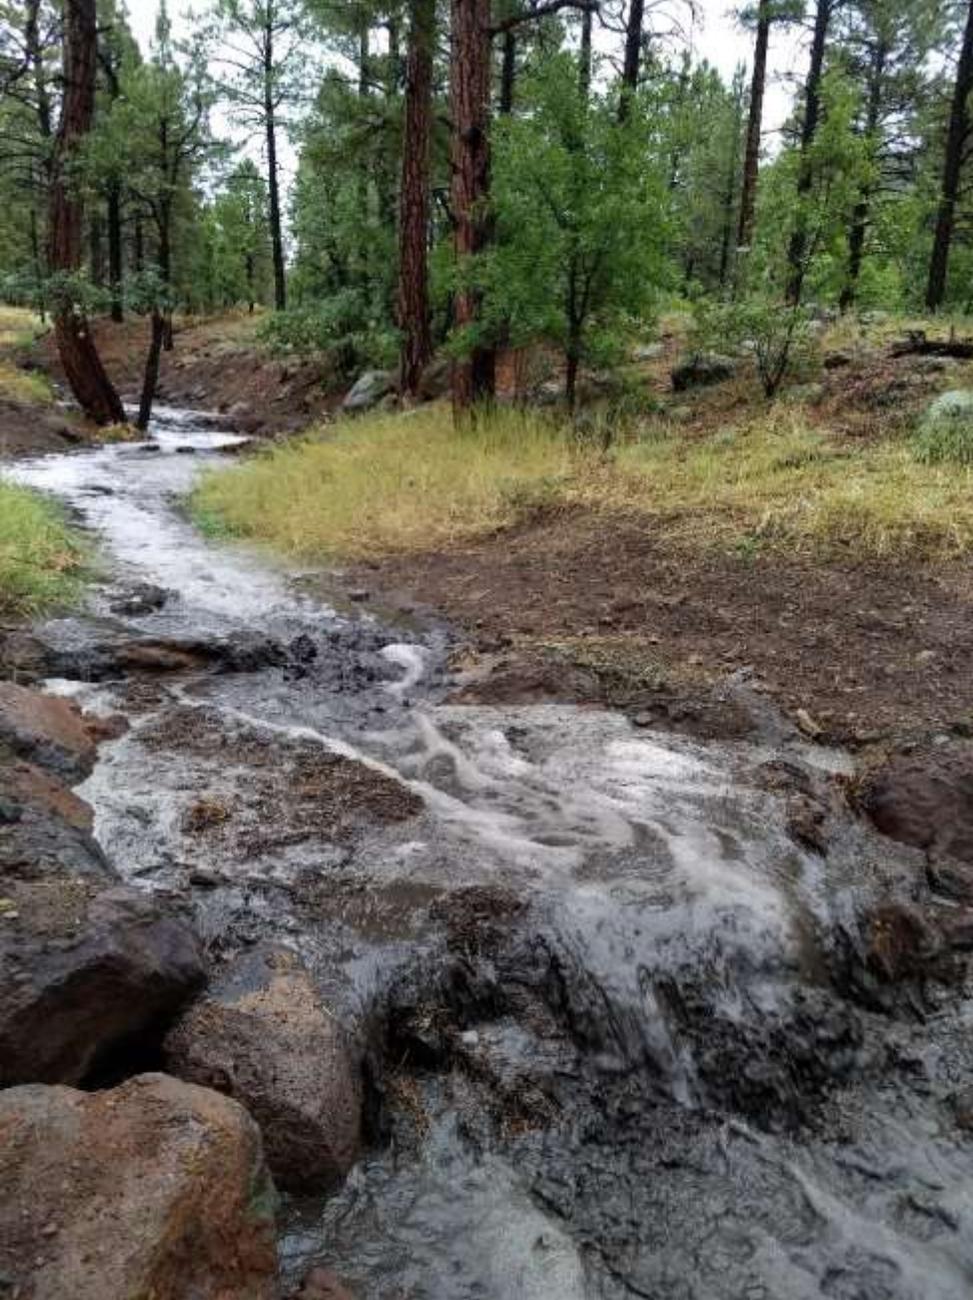
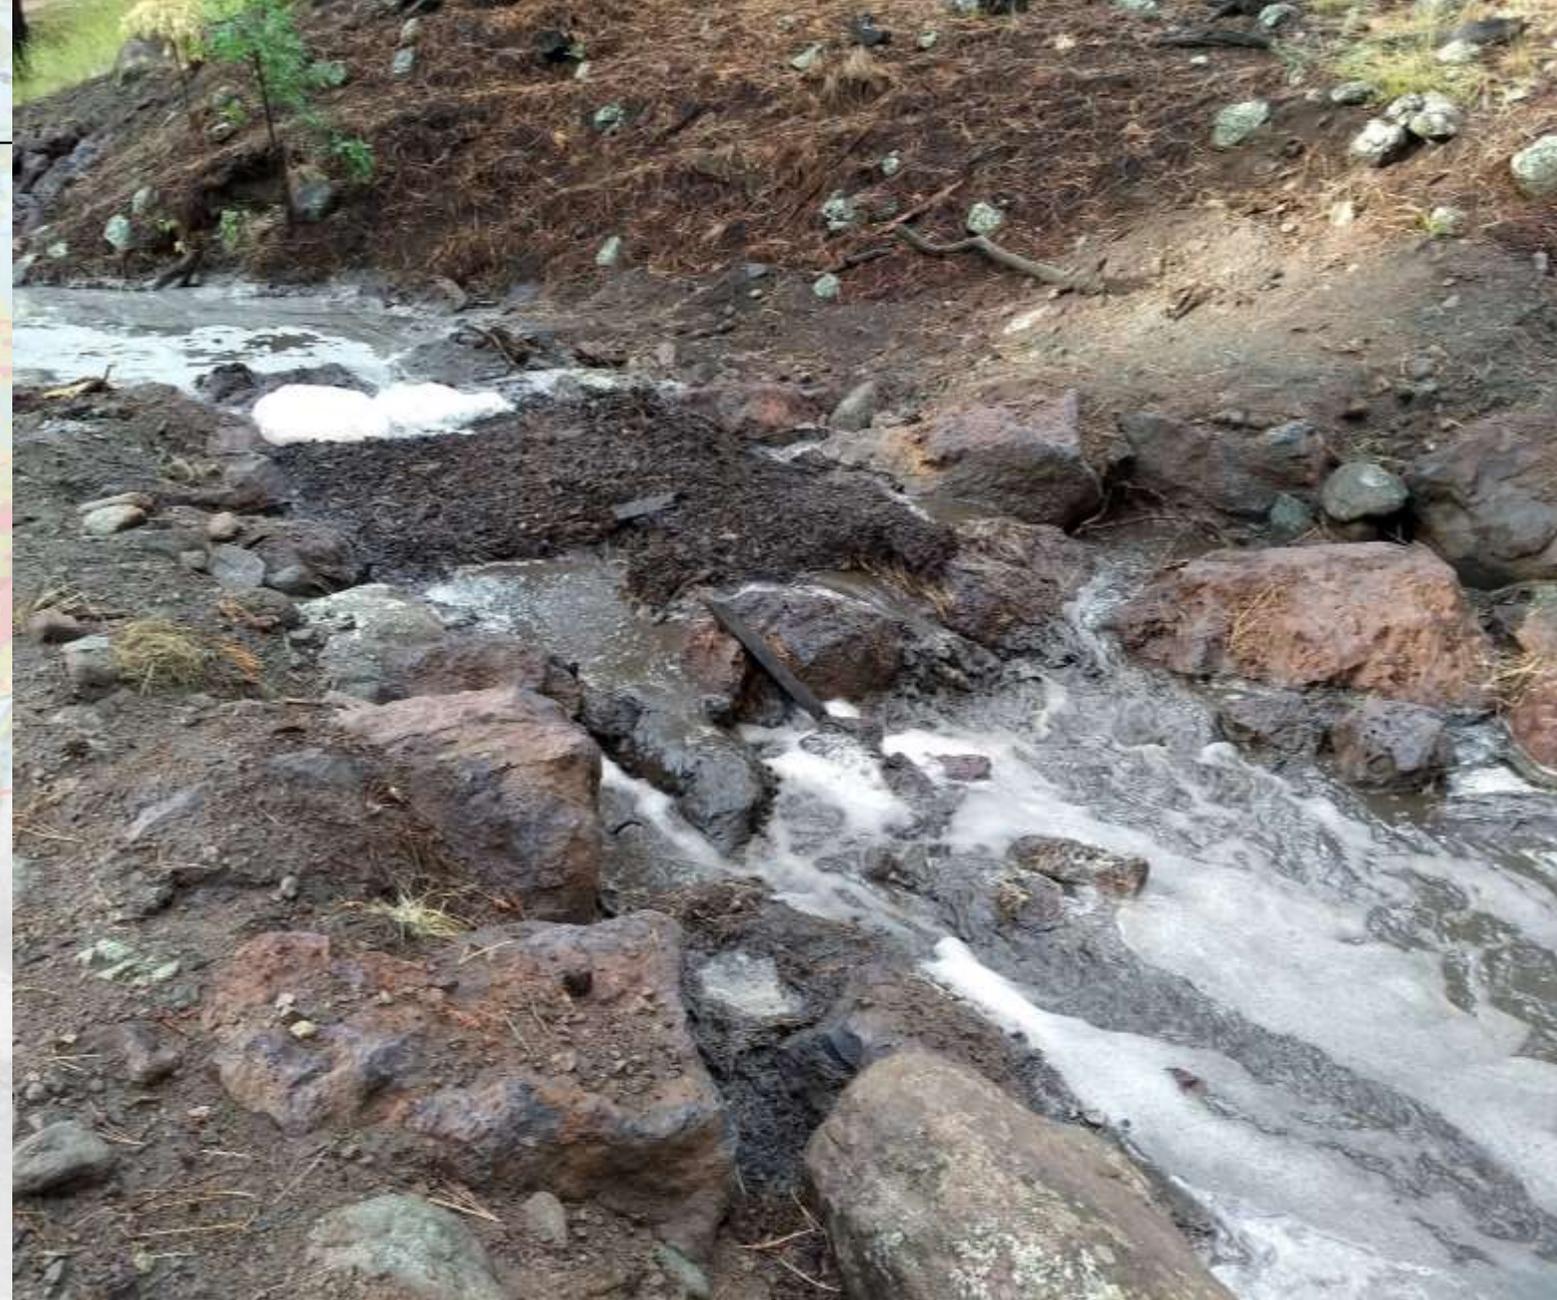
Seven cross-vein weirs with 4 foot keystone members to protect existing water main and natural gas pipeline

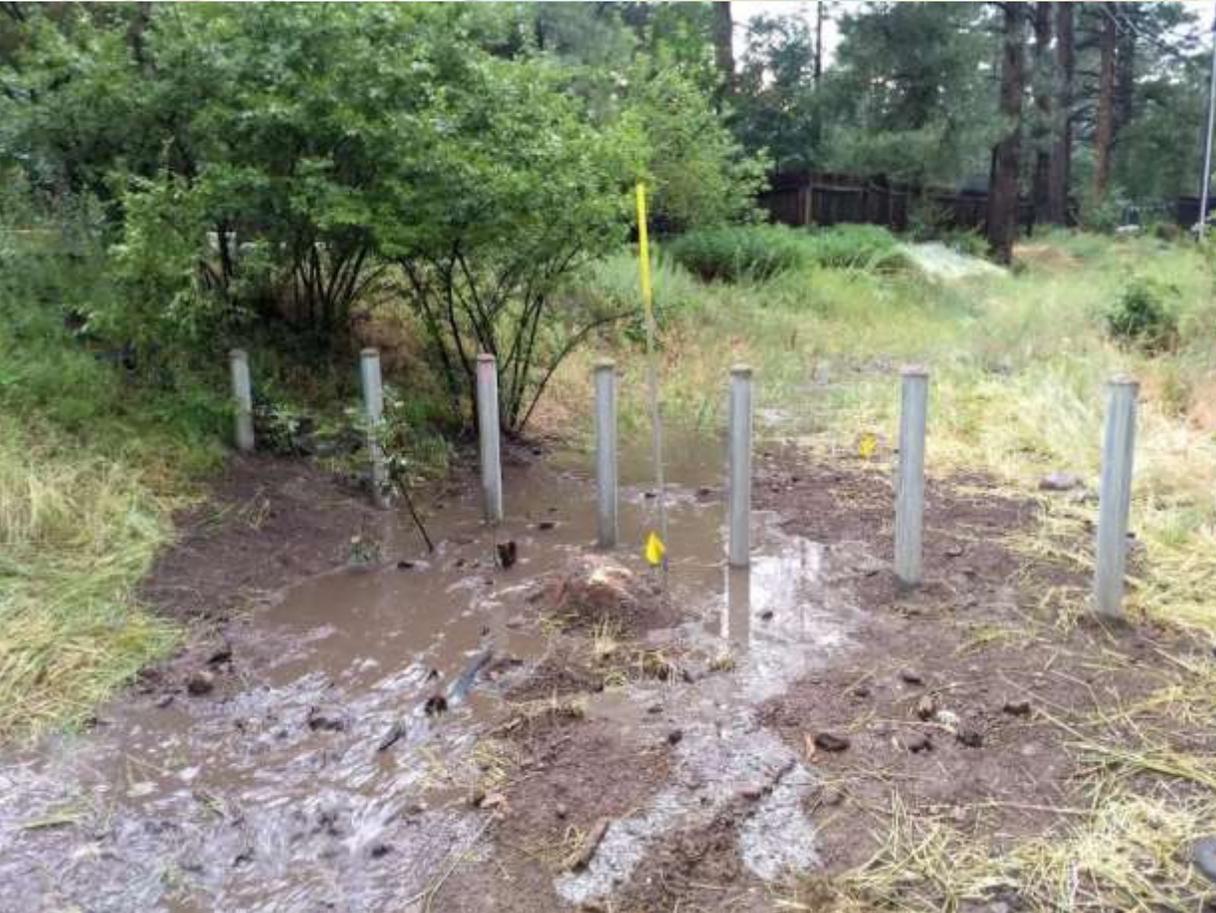
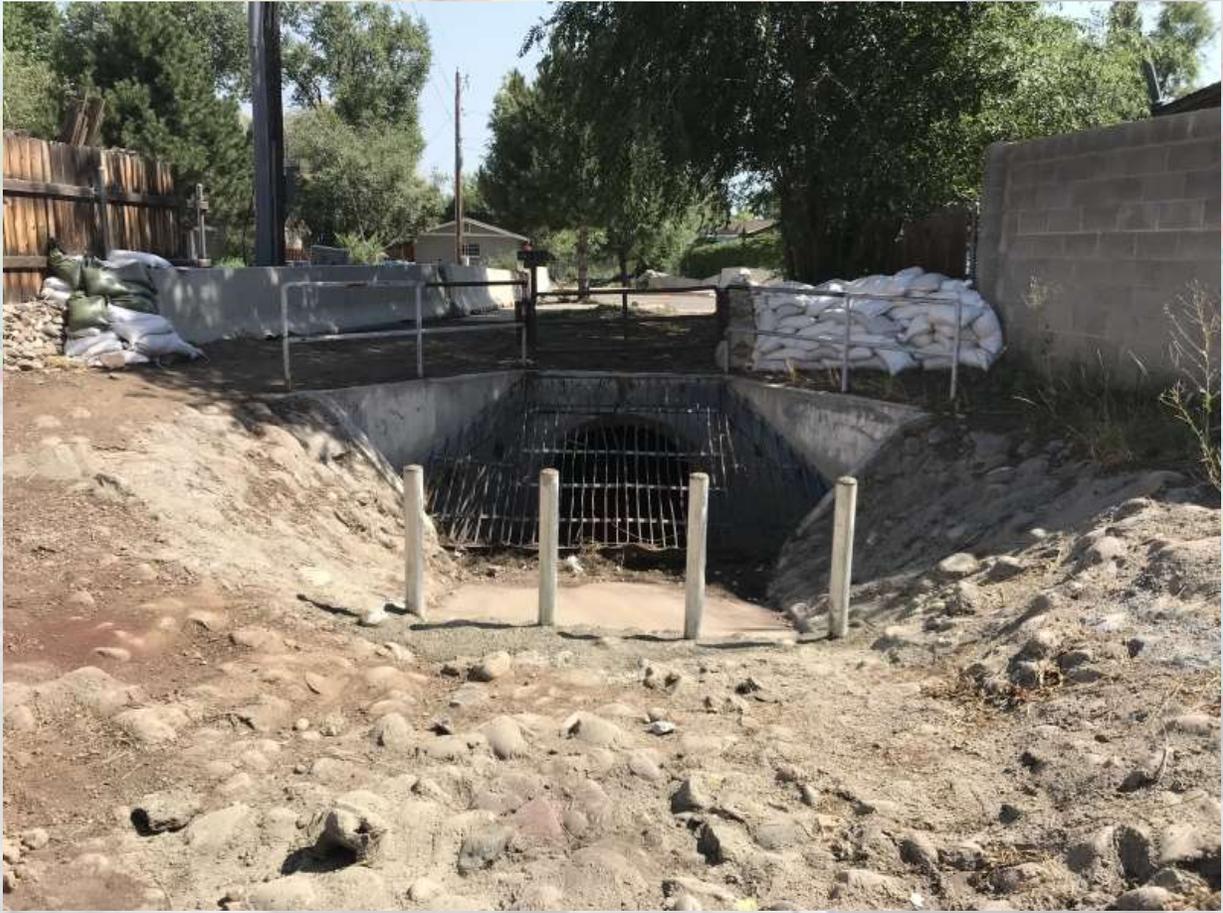
New debris bollards at Linda Vista and Dortha
