# WATER RELIABILITY TODAY & TOMORROW

## Facility Infrastructure Getting Tanked Up this Summer

### New Tanks Enhance Efficiency and Quality

Post Date: 8/31/2021

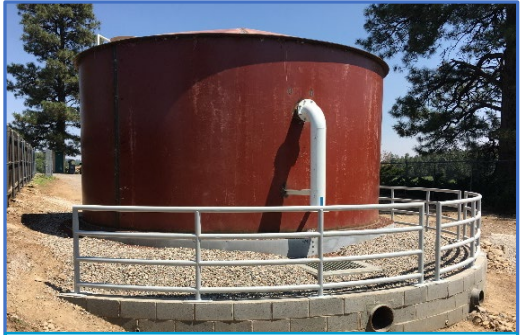
Continental Well tank waiting for piping and paint

**Continental Well** is getting a 20,000-gallon storage tank and booster pump, bringing this well up to the same configuration as the other wells in Flagstaff's water system. The storage tank will allow air in the groundwater to escape and an on-site chlorine generator provides consistent and safe chlorine delivery. The new booster pump system will ensure that the well can respond to current demands. Adding the storage tank simplifies and reduces maintenance while eliminating water loss when the well is running. Operations are monitored remotely, through the master SCADA system.

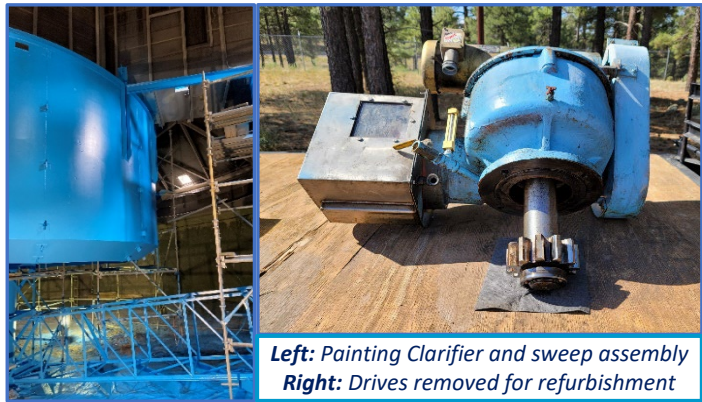
Left: Painting Clarifier and sweep assembly  
Right: Drives removed for refurbishment

**Rio de Flag Water Reclamation Plant** just completed refurbishing the first of two sets of primary and secondary clarifiers, which settle out the solids from wastewater. Crews sandblasted and painted the metal structures inside the clarifiers, inspected and rehabilitated all drives, motors, and gearboxes. This was original equipment from 1993; the just-in-time repairs revealed the drives were starting to fail. Follow this project's [story map](#) on our CIP page.
